FIELD ADVISORY

FA#98-003
January 10, 1998

**SUBJECT: Installation and Modifications for new U801 prescaler in LTR® 86xx series
Mobiles**

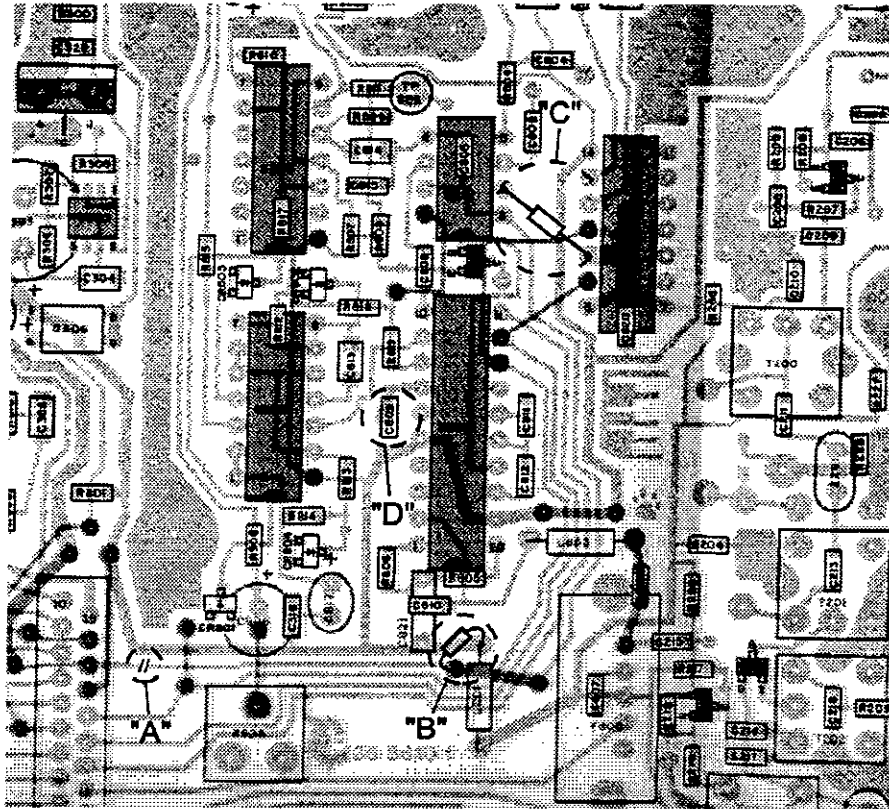
800 MHz Boards Only

Due to the obsolescence of the Prescaler chip (U801) used in the LTR 8605, 8606, 8610, 8615, 8616, 8620, 8621, 8622 and 8655 Mobile radios the following modifications need to be made when replacing U801 with the new Prescaler. For convenience, a Prescaler Replacement Kit has been created and may be ordered. Each kit contains parts to replace one Prescaler.

1. Remove defective U801
2. Cut off Pin 2 of the new U801 even with the body of the chip to prevent the leg from making contact with the pad on the board when installed.

3. Insert new U801 into board
4. Cut the trace at point marked "A" shown in Figure 1 on the back of this page.
5. Remove solder from the feed-through pads shown at point "B" in Figure 1 on the back of this page.

6. Add a 569-0115-101 chip resistor to the two pads shown at point "B" in Figure 1 on the back for this page.
7. Remove C809 on all units except 8655's (C810 on 8655 only), shown at point "D" in Figure 1 on the back of this page, being careful not to damage the pads.

8. Install a 510-2625-229 capacitor in C809's position (C810 on 8655 only).
9. Install a 510-3554-104 capacitor from pin 7 of U801 to pin 10 of U803 shown at point "C" in Figure 1 on the back of this page.

10. Replace Microprocessor (U11) with new version.
