FIELD ADVISORY

FA#95-007 Revised
August 15, 1995

SUBJECT: 86XX DESENSE AND MICROPHONICS

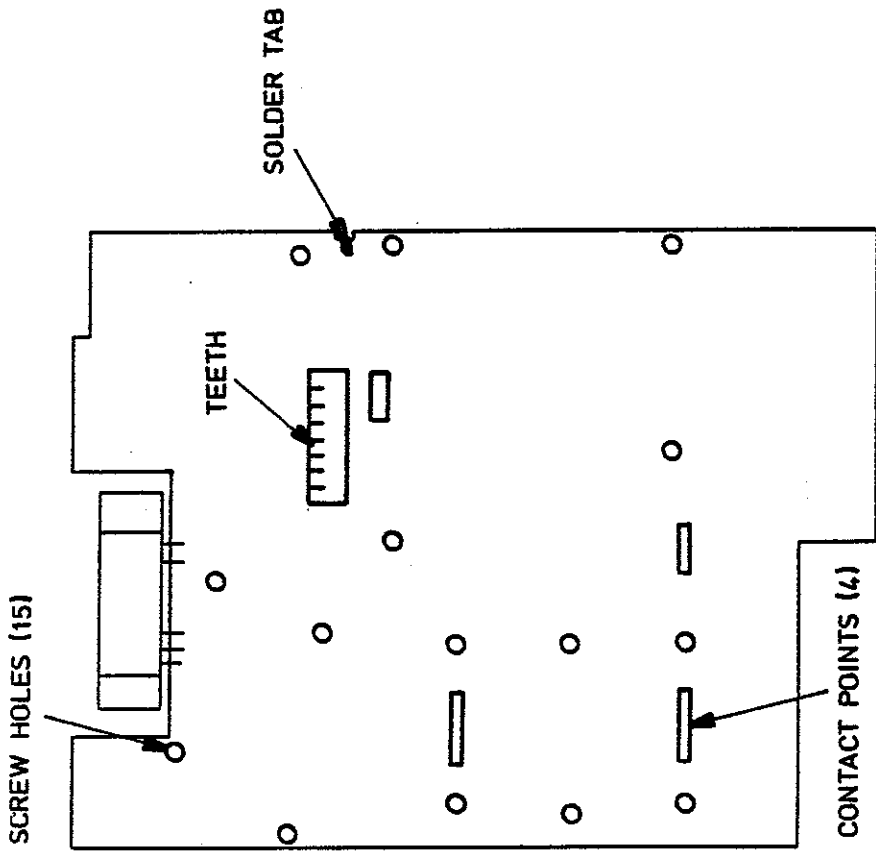
FIGURE 1

This advisory provides suggested solutions for older 86XX units that experience a desense or microphonic condition. A common cause for these conditions is excessive oxidation on some of the contact points between the zinc bottom shield and the main radio PC board. While most radios do not experience this condition, this phenomenon can occur under certain environmental conditions as the radio ages. These procedures should only be performed on an as-needed basis. Those radios that do not experience problems do not require these changes.

4. Thoroughly clean all points on the main board that make contact with the bottom shield (teeth and screw hole contact points). Remove any excess solder and solder resist that may interfere with the contact between the shield and the main board. See Figure 1.

1. Remove the radio covers.
2. Remove the bottom shield on the main board.
3. Thoroughly clean all teeth and screw hole areas of the shield that contact the main board with a soft wire brush or an ink eraser. When properly cleaned, these areas should appear shiny.

7. Solder the Z200 ground bracket tab nearest to the wall of the radio to its ground trace located near the edge of the bottom side of the main board if required. Remove the solder resist if necessary. See Figure 1.

8. Apply a thin layer of contact lube to the teeth and screw hole contact points on either the main board or the bottom shield itself. See Figure 1.
