FIELD ADVISORY

FA#95-005 Revised
May 31, 1995

SUBJECT: Replacing U601 On 86XX Mobile Radios

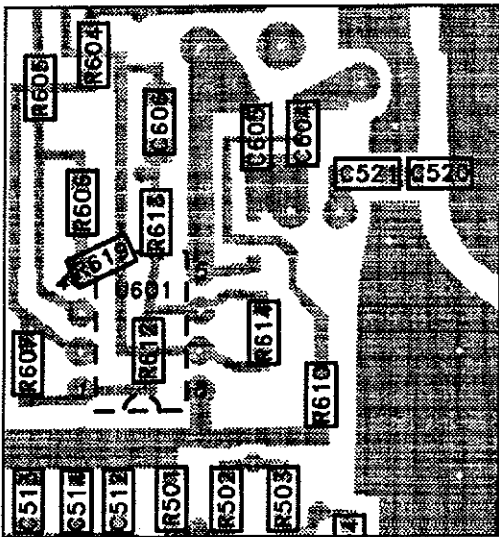
Older 8600/01/02/04/22/25/40/44 U601 Board Layout
R619 Soldered From Pin 4 U601 to Nearby Trace
Figure 1

If the 10K Ω resistors (R618 & R619) described in the previous paragraph are not present on the board layout (see figure 2 on the last page), then the main radio PC board is an older version. When changing U601 to a device with a part number of 544-2019-003 on an older version board, an add-on 10K Ω chip resistor (*pn 569-0115-103*) will need to be installed on the bottom side from pin 4 of U601 to the adjacent trace that goes to pin 7 of U601. This 10K Ω resistor is used as the pull-down resistor (R619) for the output of the second stage of U601. To install this resistor, it will be necessary to scrape away some of the green solder resist on the trace that is going to pin 7 before it will be possible to solder both ends of the chip resistor. The resistor will need to be installed at an angle. See figure 1 on the last page for more details on the proper placement of R619.

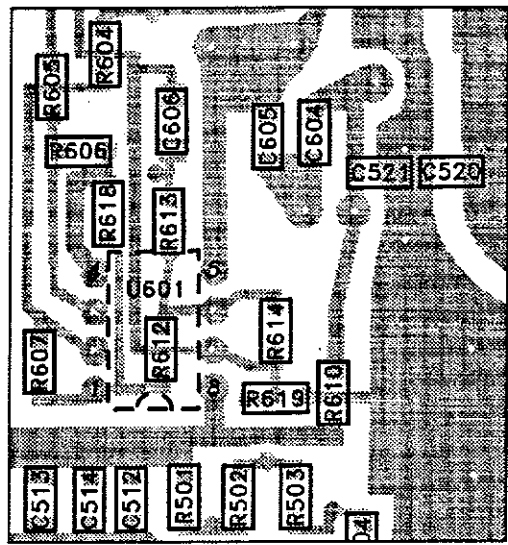
Newer 8600/01/02/04/22/25/40/44 U601 Board Layout
R618 & R619 are laid out on the board
Figure 2

New version main radio PC boards incorporate the 10K Ω pull-down resistors on the board layout. This newer board has a 10K Ω chip resistor (R619) located near pin 8 of U601 (pin 7 pull-down resistor) and a 10K Ω chip resistor (R618) located near pin 4 of U601 (pin 1 pull-down resistor). If these resistors are present on the main PC board, then the replacement device can be installed with no further modification necessary. For more details on the layout differences in the U601 area between the newer and older main PC board, see figures 1 and 2 on the last page.

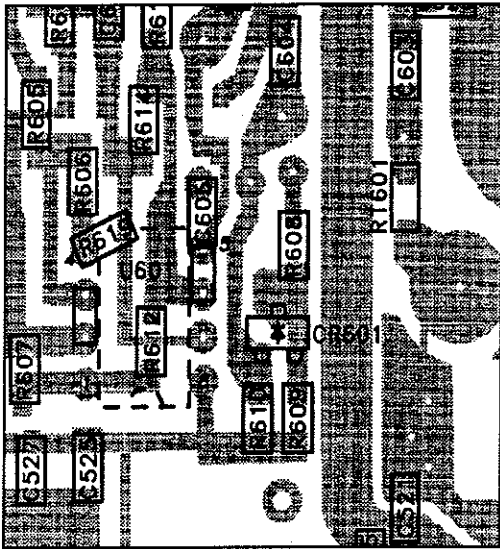
Older 8605/06/10/15/16/20/21 U601 Board Layout
R619 Soldered From Pin 4 U601 to Nearby Trace
33 pf chip caps. added as required from pins 2 to 3 and pins 5 to 6
C605 shown in its new location coming off pin 5 of U601
Figure 3

If the 10K Ω resistors (R618 & R619) described in the previous paragraph are not present on the main PC board layout (see figure 4 on the last page), then the board is an older version. When changing U601 to a device with a part number of 544-2019-003 on an older board, an add-on 10K Ω chip resistor will need to be installed on the bottom side from pin 4 of U601 to the adjacent trace that goes to pin 7 of U601. This 10K Ω resistor is used as the pull-down (R619) for the output of the second stage of U601. To install this resistor, it will be necessary to scrape away some of the green solder resist on the trace that is going to pin 7 before it will be possible to solder both ends of the chip resistor. The resistor will need to be installed at an angle.

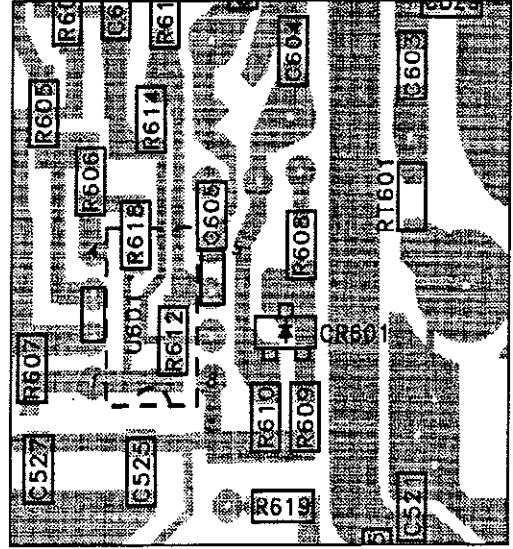
Newer 8605/06/10/15/16/20/21 U601 Board Layout
R618 & R619 are laid out on the board
33 pf chip caps. added as required from pins 2 to 3 and pins 5 to 6
C605 shown in its new location coming off pin 5 of U601
Figure 4

All above listed radio models with a build date of early July, 1994 or later, will likely have the newer main PC board. These newer boards incorporate the 10K Ω pull down resistors on the board layout. The newer board has a 10K Ω chip resistor (R619) located near R610 and R609. R619 is the pull-down resistor for U601 pin 7. Another 10K Ω chip resistor, R618, is located near pin 4 of U601. R618 is the pull-down resistor for U601 pin 1. If these resistors are present on the main PC board, then the replacement device can be installed without the need of installing pull-down resistors.

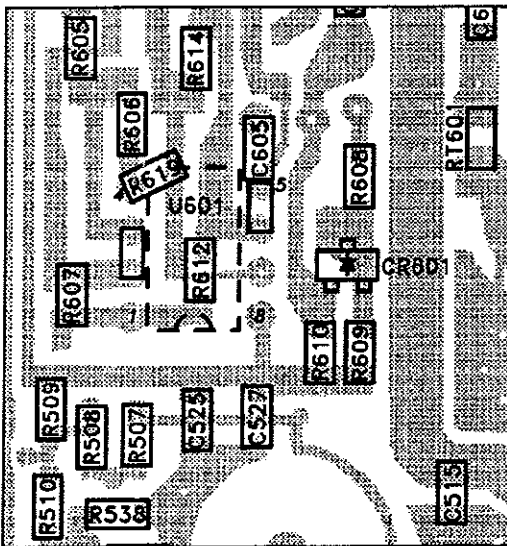
Older 8655 U601 Board Layout
R619 Soldered From Pin 4 U601 to Nearby Trace
33 pf chip caps. added as required from pins 2 to 3 and pins 5 to 6
C605 shown in its new location coming off pin 5 of U601
Figure 5

If the 10K Ω resistors (R618 & R619) described in the previous paragraph are not present on the main PC board layout (see figure 6 on the last page), then the board is an older version. When changing U601 to a device with a part number of 544-2019-003 on the older board, an add-on 10K Ω chip resistor will need to be installed on the bottom side from pin 4 of U601 to the adjacent trace that goes to pin 7 of U601. This 10K Ω resistor is used as the pull-down (R619) for the output of the second stage of U601. To install this resistor, it will be necessary to scrape away some of the green solder resist on the trace that is going to pin 7 before it will be possible to solder both ends of the chip resistor. The resistor will need to be installed at an angle.

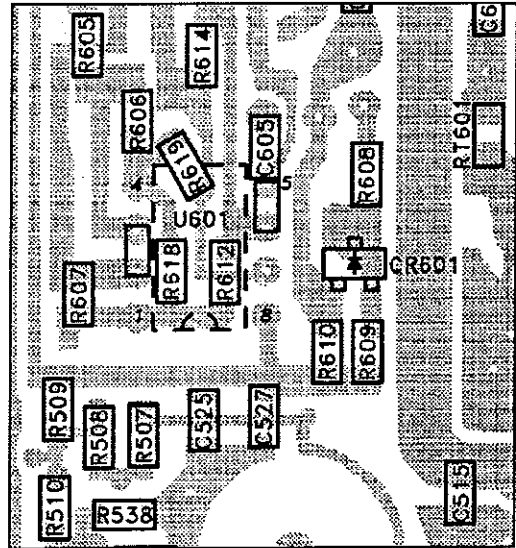
Newer 8655 U601 Board Layout
R618 & R619 are laid out on the board
33 pf chip caps. added as required from pins 2 to 3 and pins 5 to 6
C605 shown in its new location coming off pin 5 of U601
Figure 6

All 8655 model radios with a build date of early July, 1994 or later, will likely have the newer main PC board. These newer boards incorporate the 10K Ω pull down resistors on the board layout. The newer board has a 10K Ω chip resistor (R619) located at an angle near pin 4 of U601. R619 is the pull-down resistor for U601 pin 7. Another 10K Ω chip resistor, R618, is located near pin 1 of U601 (and directly parallel to R612). R618 is the pull-down resistor for U601 pin 1. If these resistors are present on the main PC board, then the replacement device can be installed without the need of installing pull-down resistors.
