SUBJECT: **Modification to improve crunch problems with 800 MHz MPA's**

Modification required for MPA retry problems due to aging radios. This applies to 800 MHz radios which have begun to exhibit a retry problem. There is no need to make these modifications to radios which do not exhibit this problem.

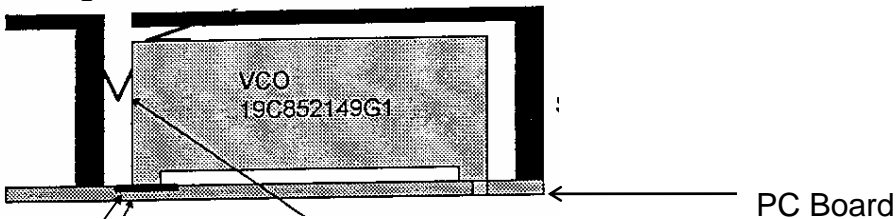
Copper ground spring Part Number 19B235901P1.

This spring is soldered to the upper edge of the VCO as shown. Do not use excessive solder. Spring must still compress after being soldered.

Casting Wall

8) An additional copper grounding spring must be soldered on the top of the VCO. See diagram for placement.

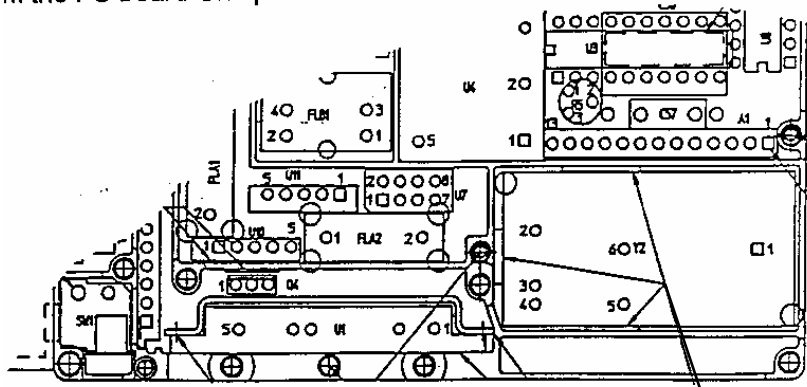
The two unsolder corners of the VCO must be insulated from the PC board Gnd plane.

6) The two unsoldered corners need to be insulated from the Gnd pattern beneath the legs. This can be done with Teflon tape.

7) After ensuring that all via holes are cleaned out, the VCO can be put back into place. Note that the VCO must be a I9C852149G1 before placing back on the board. Put the VCO back on the board making sure that the unsoldered corners can no longer make contact with Gnd. It is very important to ensure that the corners cannot touch the ground plane or else the problem will reoccur (especially after several months of service in the field). Solder the VCO back into place.

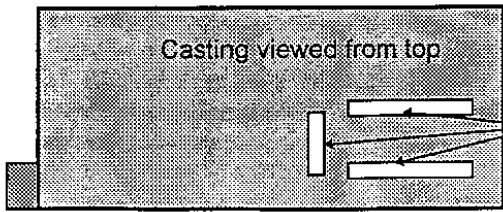
Casting Viewed from top

↑
Placement of 3 copper grounding springs.

11) The copper grounding springs need to be put back in place. Push all 3 shields in around the VCO and verify that they drop below the edge of the eggcrate top surface. Also these shields should make contact between the sides of the VCO and the eggcrate.
