Orion Keypad Frequency Select Board AE/LZY 213 881/1

This document contains Software Release Notes for Orion Keypad Frequency Select Board Software, product number LZY 213 881/1, R-state R3E.

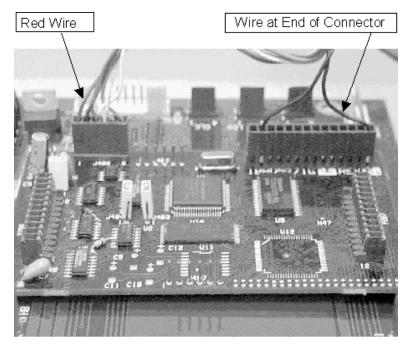
Figure 2. Cable Installation

5771 board's J401. Note the orientation of the connectors (refer to Figures 2 and 3). The red wire in the cable should be closest to the TO220 regulator. P408 supplies the data, flash voltage supply, an external reset, and a line that disables the 5771 board's 485 receive driver. The 485 driver must be disabled or else it will conflict with the computer's RX data path into the RCP.

P401 grounds pin 13 which, at reset, tells the RCP to enter its program mode. Its program mode is also our flashing mode. The orientation of this connector should be as follows: the end with the cable at the edge of the connector should be placed in the corner of the board.

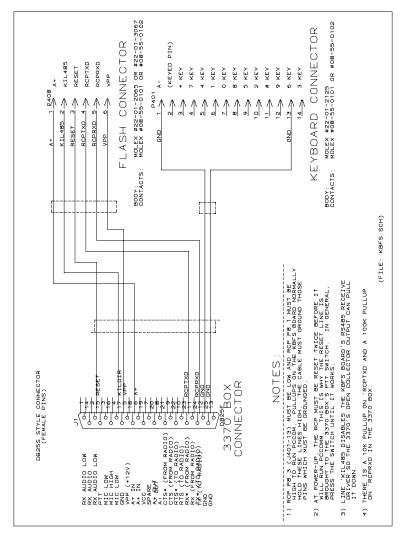
Figure 3. Connector Details

Connect the DB25 end of the flashing cable to the radio end of the TQ3370 box. Connect the cable's six pin connector (P208) to the 5771 board's J408. Connect the cable's fourteen pin connector (P401) to the
